National Register of Historic Places Registration Form

historic name McCartney, James H. and Mayetta (Degrush), House

street & number 214 2nd Street SE not for publication

city or town Mount Vernon vicinity

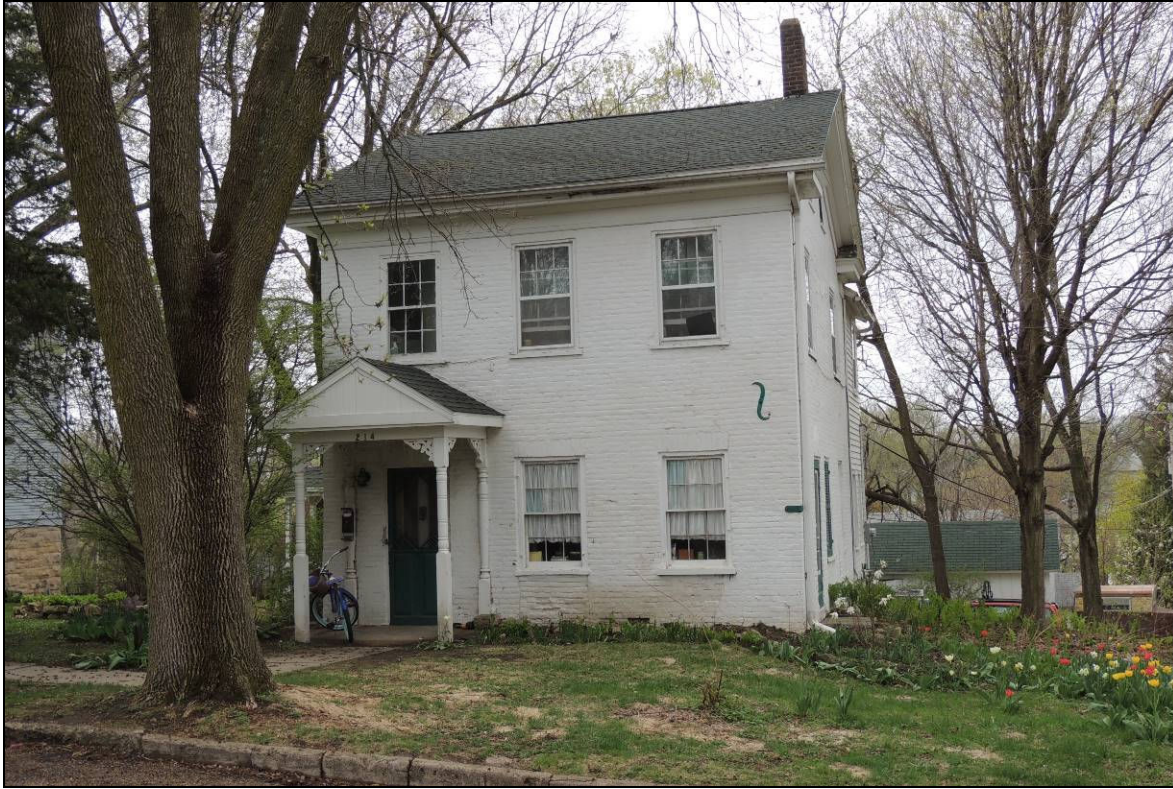
Figure 1. Façade of the McCartney House looking South. Photograph taken May 2, 2018.

The façade is the northerly face of this house and exhibits three-rank fenestration with the first story having the front entry door to the left and two 6/6 double-hung, wooden-sash windows evenly spaced to the right of the door (Figures 1-2). Originally, the center window was the front door when the house was a single story. When the second story was added, the door was shifted to the left side and now opens into a long hall that runs the depth of the two-story portion of the house. The shifting of the door is evidenced by the brick infill below the center window. The second story of the façade has three 6/6 double-hung, wooden-sash windows evenly spaced across. Above these windows is a wide frieze board under the moderate eave overhang and boxed eaves. The front door has a wooden screen door and is sheltered by a projecting, closed-gable porch hood that has vertical beadboard siding in the gable end and a slight eave overhang. The porch hood is supported by two full and two half spindle posts. The outer posts have scroll-cut brackets on the interior side of each post, while the two half posts at the brick wall flanking the front door only have brackets perpendicular to the house. The posts are set on a concrete slab that is not original. The porch is of historic age, but its Queen Anne detail of the turned spindle posts indicates a date of the 1890s-early 1900s. Of additional note on the façade is the tie rod at the first/second floor break. The tie rod has an S-curve wrought iron exterior bracket. A late 20th century photograph of the house showed it with functional shutters on the windows and a wooden plank fence along the street frontage (Figure 2). The current owner noted that the wooden shutters had deteriorated beyond saving, but he salvaged the handmade iron pulls on the shutters and used them for pulls on the kitchen cabinets (Slaton Anthony, personal communication, March 2019).

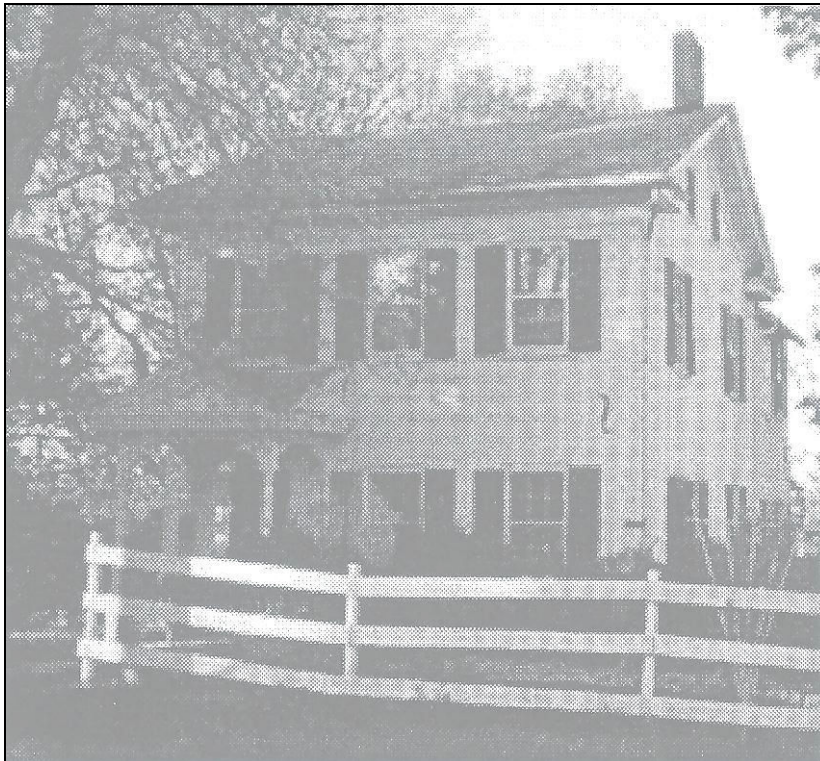
Figure 2. Undated but probably late 20th century photograph of the McCartney House looking SSE. Note that the windows then had aluminum-framed storm windows and shutters that have since been removed. Photograph obtained from Mount Vernon Historic Preservation Photograph Archives.

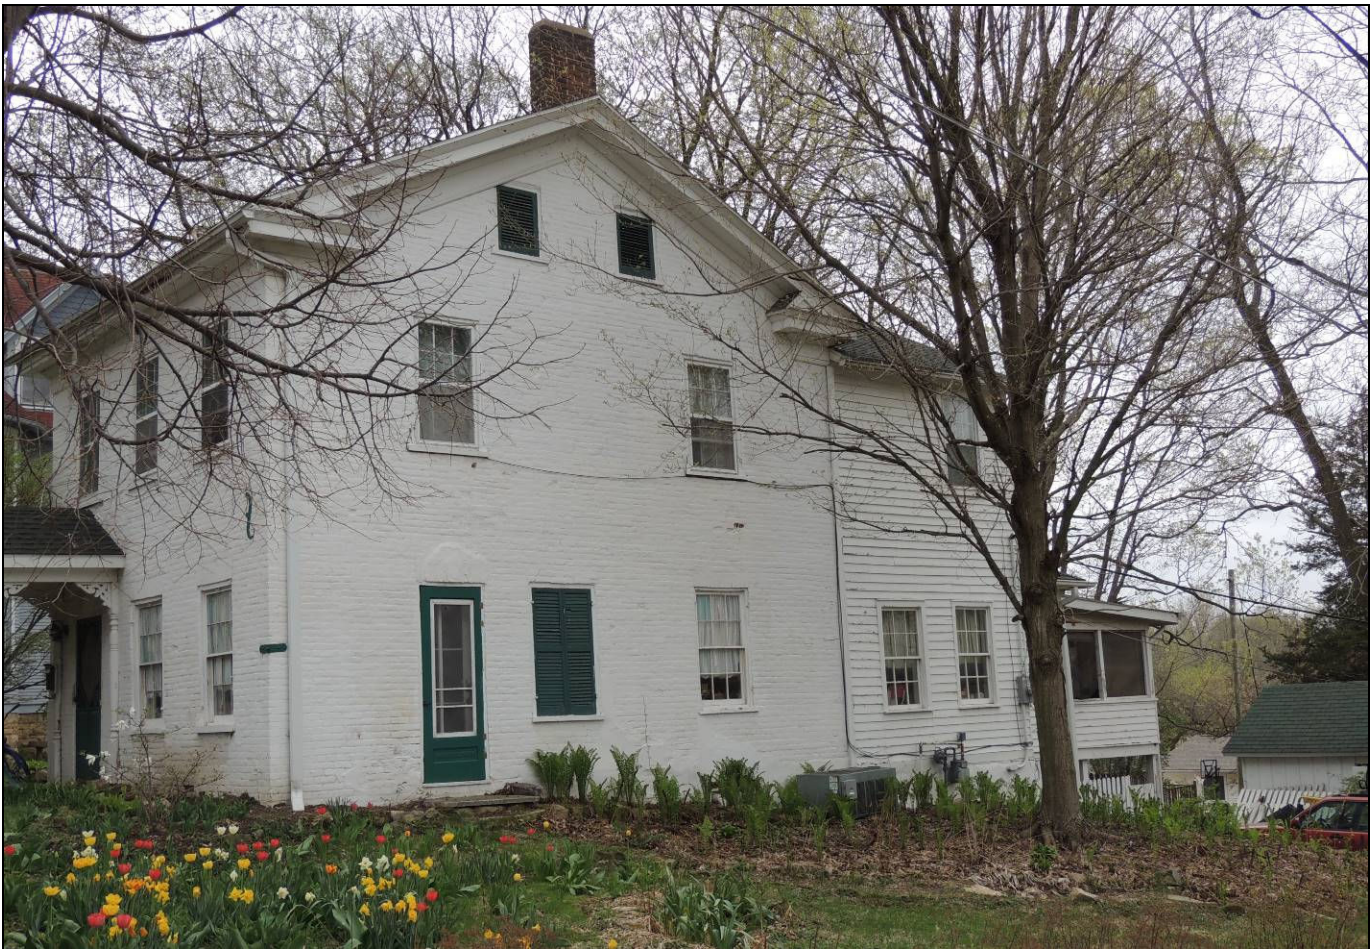
Figure 3. West side of McCartney House looking SSE. Photograph taken May 2, 2018.

This side of the house has a single door to the left side on the first story, with two windows to the right that are not evenly spaced (Figure 3). The reason for the uneven spacing is the presence of an interior chimney centered on the wall. The window just to the right of the door is covered by closed wooden shutters on the exterior and is filled with brick on the interior. The window to the far right is a 6/6 double-hung. The second story has two 6/6 double-hung, wooden-sash windows placed to the left and right sides with no window in the center. The attic level has two small rectangular windows on either side of the interior chimney just below the wide frieze boards. The windows are each covered with a single wooden shutter on the outside. The boxed eaves on this gable end have cornice returns with cornice molding. The two-story rear ell has two 6/6 double-hung, wooden-sash windows on the first story of the west side, with a single 6/6 double-hung, wooden-sash window to the right side of the second story. This rear ell has wooden clapboard siding.

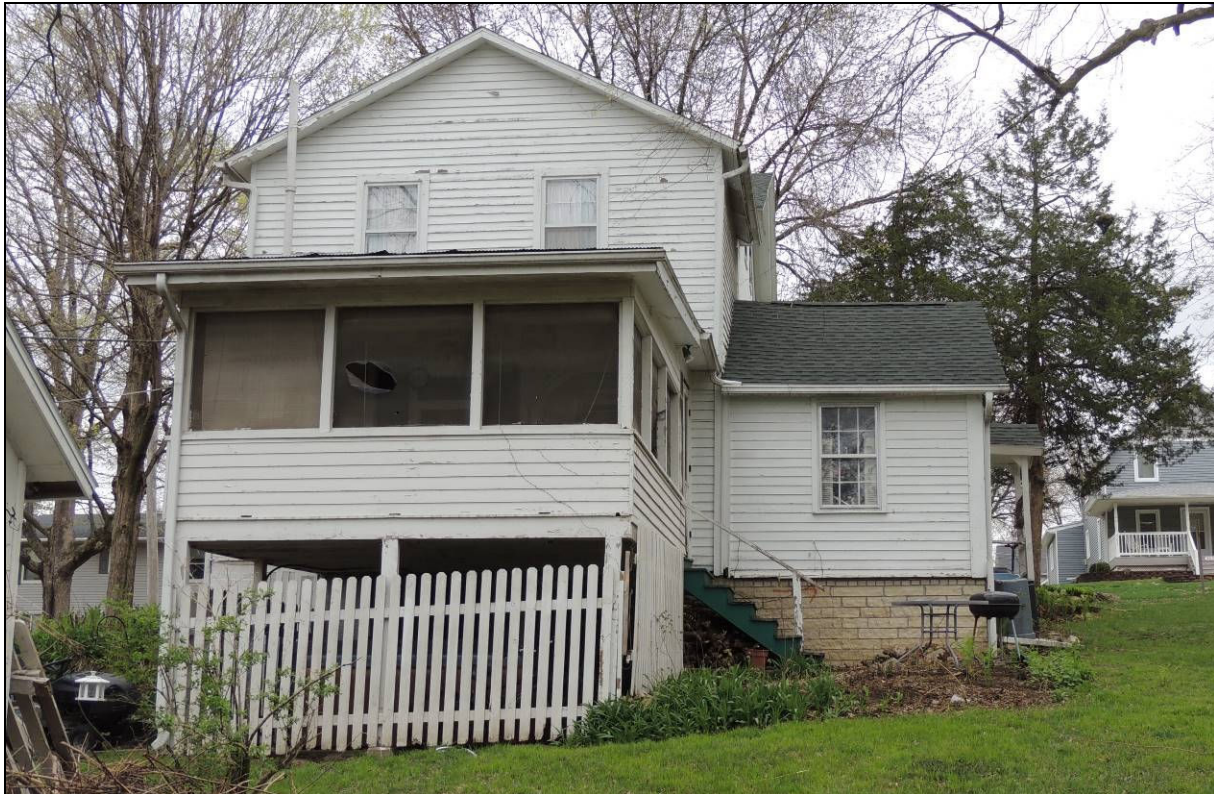
Figure 4. Rear of McCartney House looking NNE. Photograph taken May 2, 2018.

All three stories of the house are visible at the rear including the basement level and the two upper floors (Figure 4). The rear of the gable end portion of the house has an enclosed bathroom addition with a hip roof on the left side on the first floor. The stone foundation bumps out from the main foundation under this addition. The bathroom addition is sided with wooden clapboards and has no exterior windows. The rest of the first floor and the basement bump-out level is covered by the enclosed porch addition on the rear

of the gabled ell. This porch has a low-pitched shed roof, large fixed-pane windows and screens around the upper portion of the porch with a clapboard-sided railing around the lower portion. Underneath the screened-in porch is lower space enclosed by with picket fencing and latticework screens for another porch/utility space. On the second story of the front-gabled ell of the house, there are two evenly-spaced 6/6 double-hung windows.

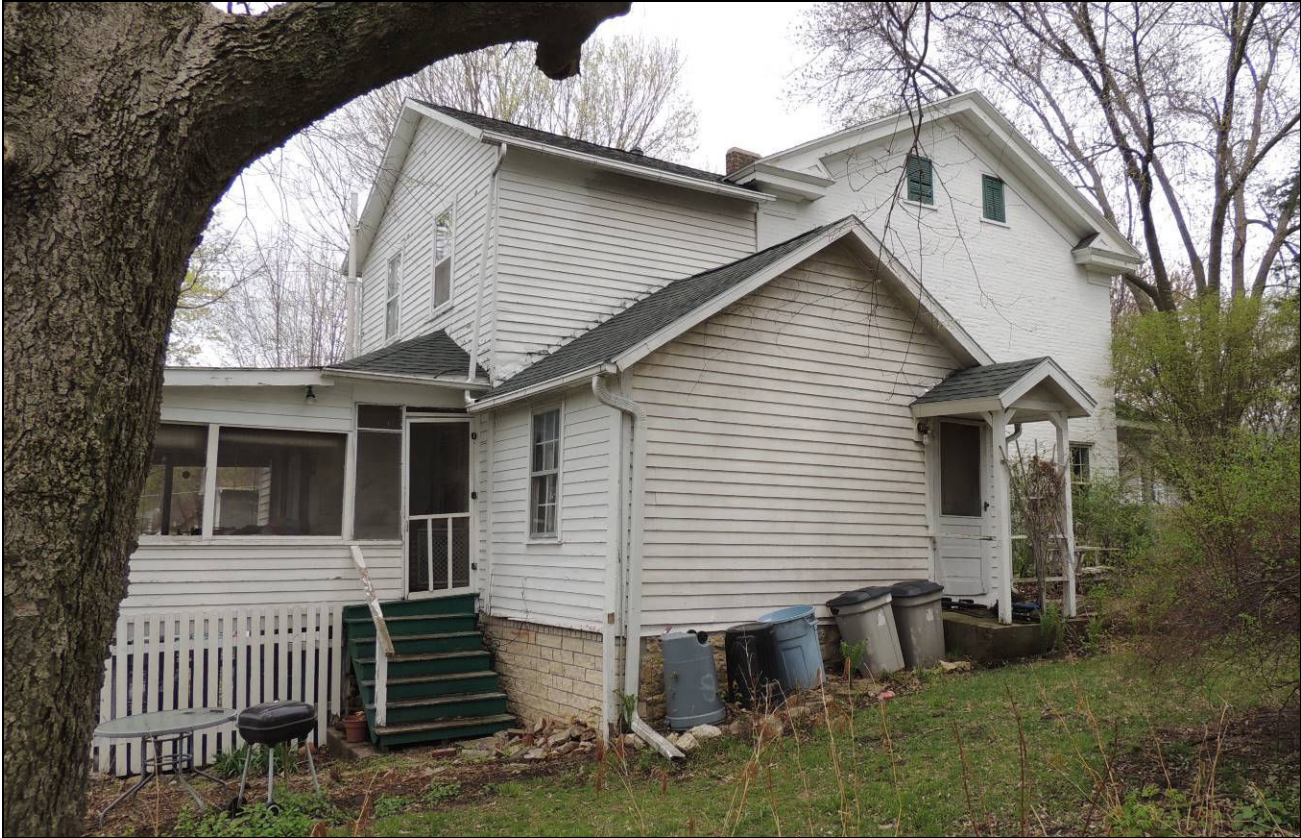
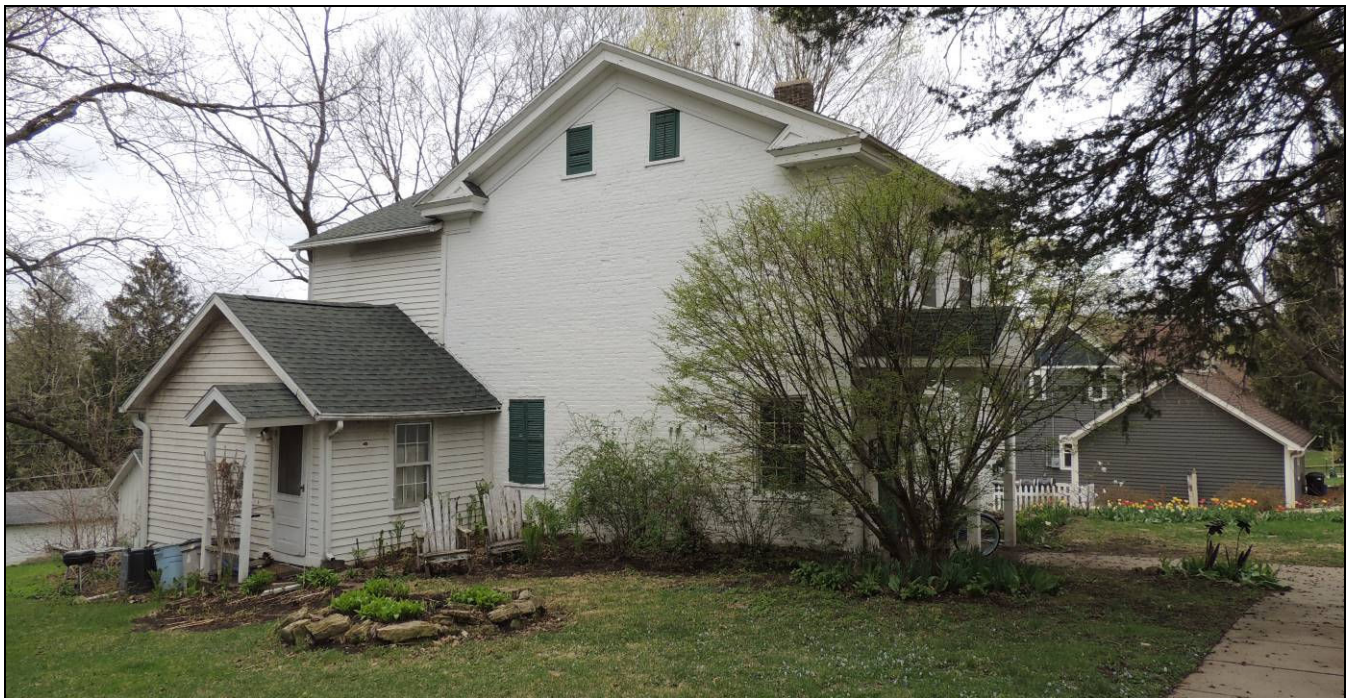
Figure 5. Rear and East side of McCartney House looking NNW. Photograph taken May 2, 2018.

Figure 6. East side of McCartney House looking West. Photograph taken May 2, 2018.

The east side of the house has another front-gabled frame addition sided with wooden clapboards and built on a limestone foundation (Figures 5 and 6). The south side of this one-story addition has a single 6/6 double-hung wooden-sash window centered on the south wall. The east side of the front-gabled addition has no windows but does have a door to the far-right side of this gable end. This door has a small gabled porch hood of modern construction supported by two square wooden posts with small angled braces just under the eaves at the top of each post. There are also no windows on this side of the second story of the frame addition off the rear of the brick portion of the house. The east side of the brick portion of the house has two small rectangular attic windows just under the eaves identical to those on the west gable end. These windows are also covered by single wooden shutters. The gable end has the same wide frieze board and cornice returns as on the west gable end. The first floor of the east side of the brick section of the house has two windows towards either side of the wall. The window to the left is covered by two wooden shutters, while the window to the right is a 6/6 double-hung, wooden-sash window.

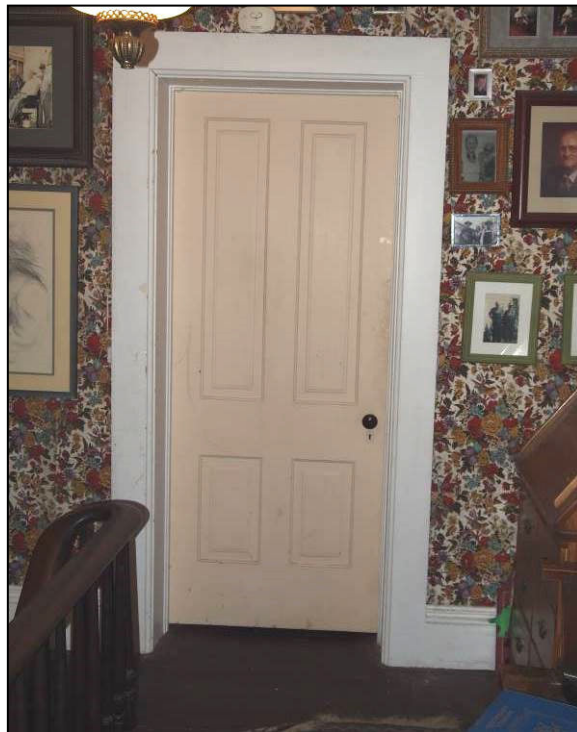
Figure 7. Interior views of the McCartney House. Top, left to right: walnut staircase in main hallway and detail of original front door and handmade door knocker; Bottom: 4-paneled wooden door on second-floor landing. Photographs taken March 23 and 30, 2019 (top) and August 8, 2018 (bottom).

The interior floor plan of the two-story section of the house shows a hall-and-parlor plan. The front door opens into a long hall that extends the depth of the house, with the walnut staircase on the east (left) side of the hall towards the rear of the hall. These stairs lead up to a landing where they then turn to the west (right) up to the second-floor hall above. Underneath the staircase are the basement stairs. The hallway on the first floor leads into the rear kitchen addition. A doorway just to the right of the front door leads from the hall into the parlor, now used as a living room. There is an exterior door in the living room that is a later addition. The main walnut staircase has a turned newel post, turned balusters and handrail that are all varnished and is original to the early 1860s enlargement of this house. The wooden surrounds of the doors and windows have peaked lintel boards and architrave trim boards that have prominent molding. Other original interior details include: cornice molding around the ceiling of the parlor; wide floor boards; baseboards that have quarter-round molding on top and at the base; a low ceiling in the parlor; the four-paneled wooden interior doors with ceramic door knobs and metal hardware; and the basement rooms that were once finished with lath and plaster, some of which remains intact (Figures 7-9). The northern room in the basement was underneath the original circa 1855 house and has an intact hewn beam from that original construction. Details added in the late 20th century to the original section of the house include a wood-and-glass door installed in the west wall of parlor and the brick fireplace and mantel to the chimney bump-out in this room by the previous owners (Shirley M. and Joseph J. Giannini). This fireplace is built of brick pavers that were salvaged from the street in front of the house when it was being repaved. Historically, this room and the room above were heated by stoves vented to the chimney. The light fixture in the hallway dates from the 1940s but was also added by the Gianninis, who salvaged it from the Tipton Movie Theater. The Gianninis also added a slate floor in the front hallway and remodeled the bathroom and dining room interiors.

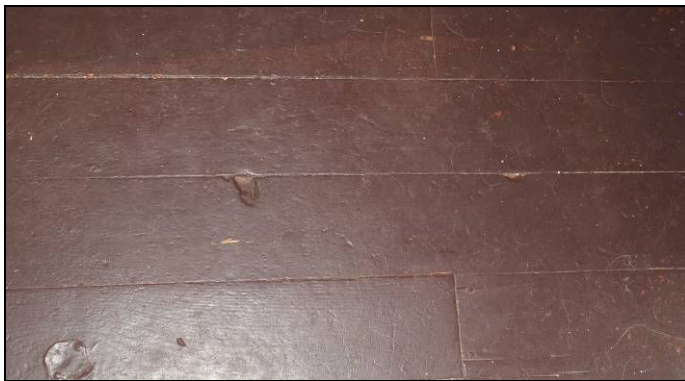
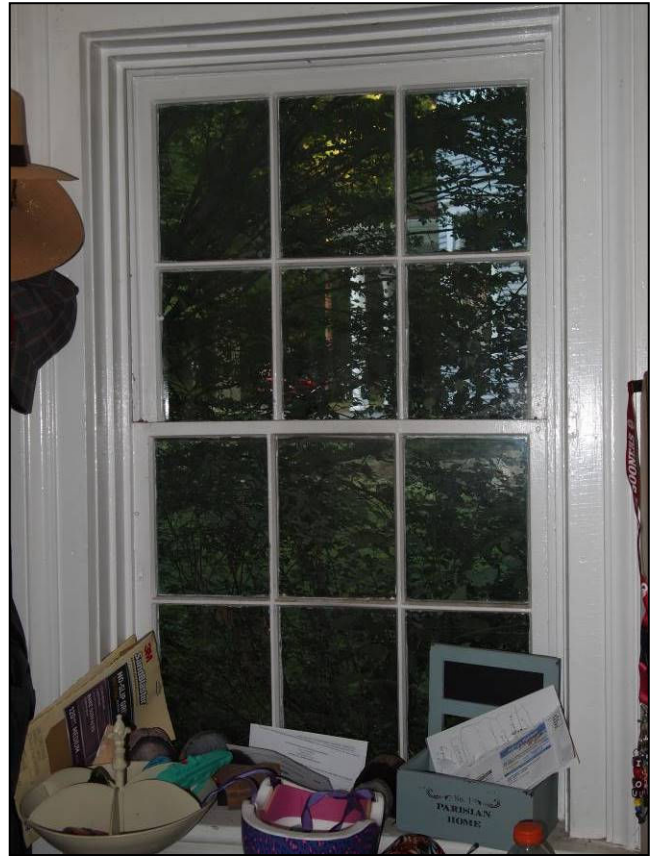
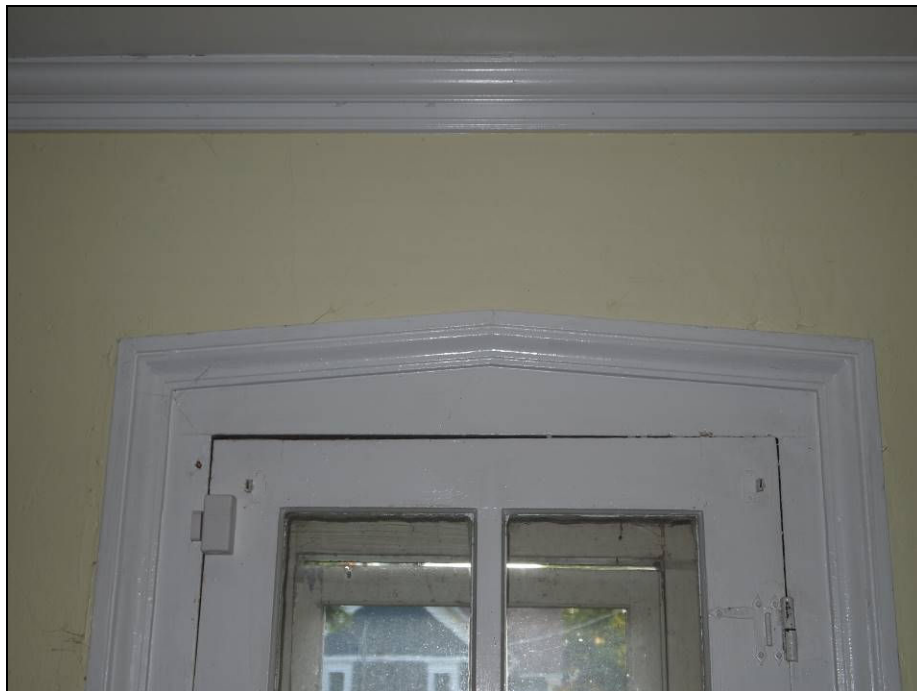
Figure 8. Interior views of McCartney House. Top, left to right: detail of floor boards (painted) and detail of 6/6 wooden-sash window in front hall. Bottom: detail of woodwork on front door and crown molding at the ceiling. Photographs taken August 8, 2018.

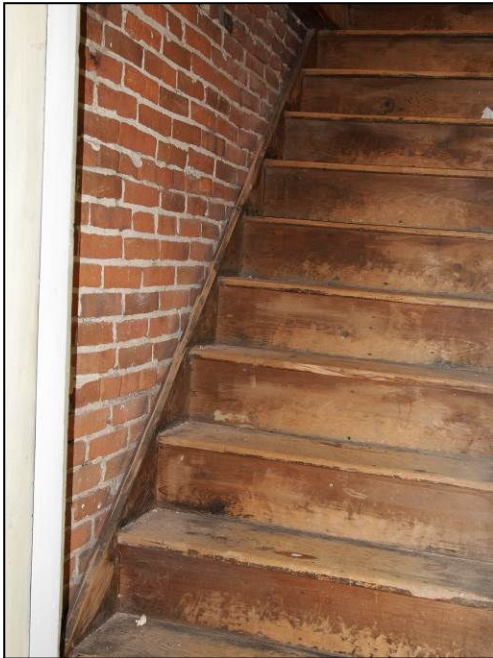
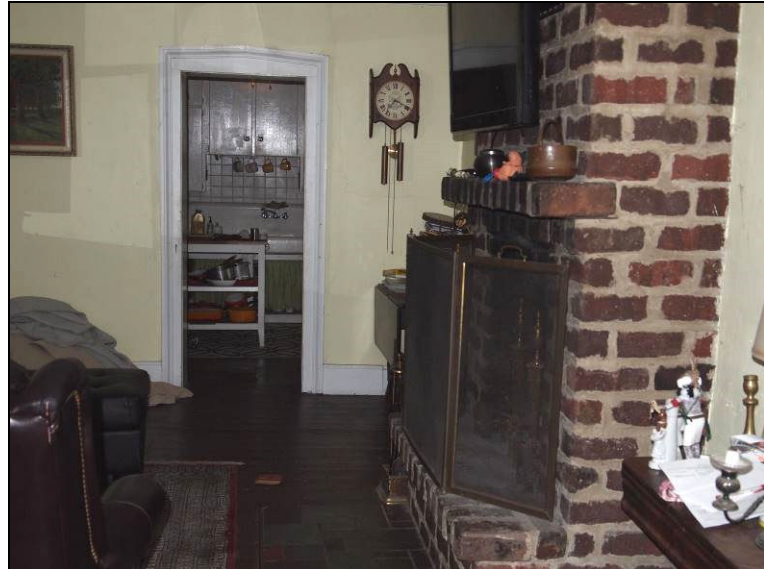
Figure 9. Interior views of McCartney House. Left: wooden stairs to attic; Right: front parlor looking towards the kitchen and showing the fireplace added by previous owners. Photographs taken August 8, 2018.

The second floor has a hallway off the staircase that leads into a front bedroom, which has a closet inside of which are the wooden stairs to the attic, which has been finished as a bedroom by the current owners. There is a second bedroom off the hallway, with a third larger bedroom in the south addition that is also entered from the hallway.

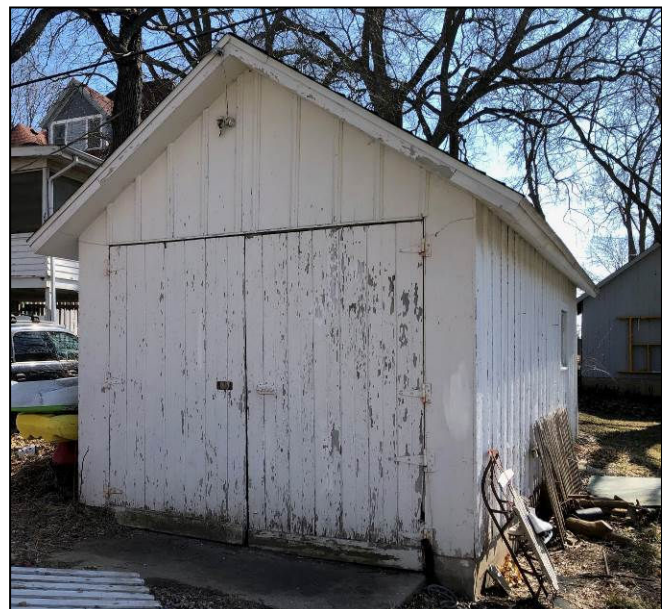
Figure 10. Garage looking East.
Photograph taken March 23, 2019.

This is a one-stall frame garage that has a front-gabled roof covered with asphalt shingles and walls with vertical board-and-batten wooden siding (Figure 10). The garage doors consist of two doors that open out and made of vertical board siding. The foundation is concrete.

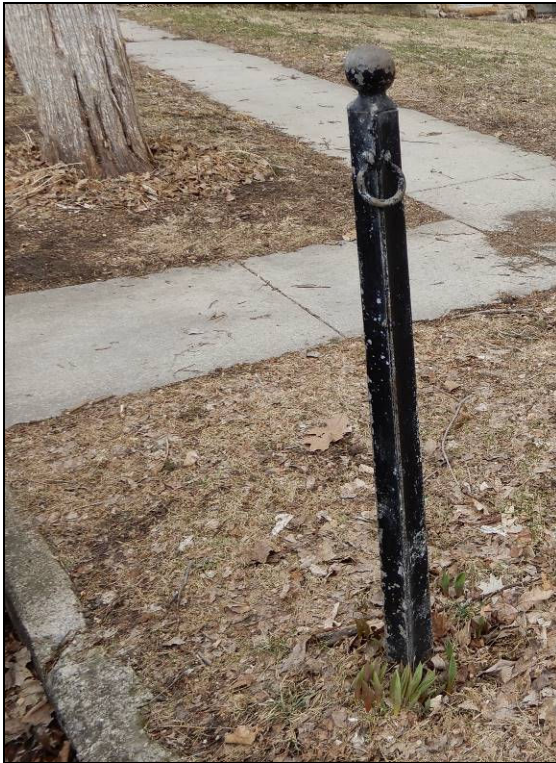
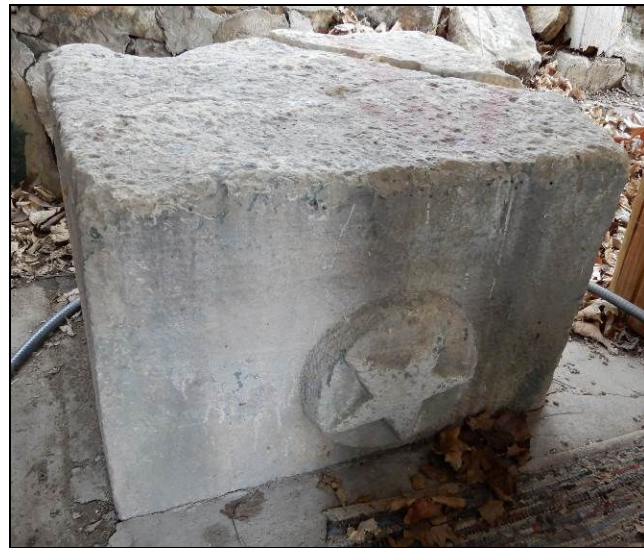
Figure 11. Left: Hitching Post; Right: Mounting Block
Photographs taken March 30, 2019.

There are two contributing objects on this property including hitching post and a stone mounting block. The hitching post is a handwrought iron triangular post with an iron ball finial and attached handwrought iron ring (Figure 11). This post is in the public right of way in front of the house but is original to the McCartney House, or at least added during the period of significance. The mounting block is a large block of rough-cut and dressed stone that has a protruding disc with a star carved near the base of the block (see Figure 11). This too is in its original location behind the house, indicating that there was once a driveway that circled around the back yard between the original stables and the house where occupants could use the stone to mount a horse or a carriage from the back of the house. Today, the location of this block is on the interior of the two-level porch structure that was added to the rear of the house in the 1970s. The mounting block and the hitching post both date from the property's period of significance and are counted as two contributing objects.
