City of Mount Vernon

Design Guidelines Booklet

**Rehabilitation and Preservation
Do's & Don'ts for
Commercial and Residential Structures**

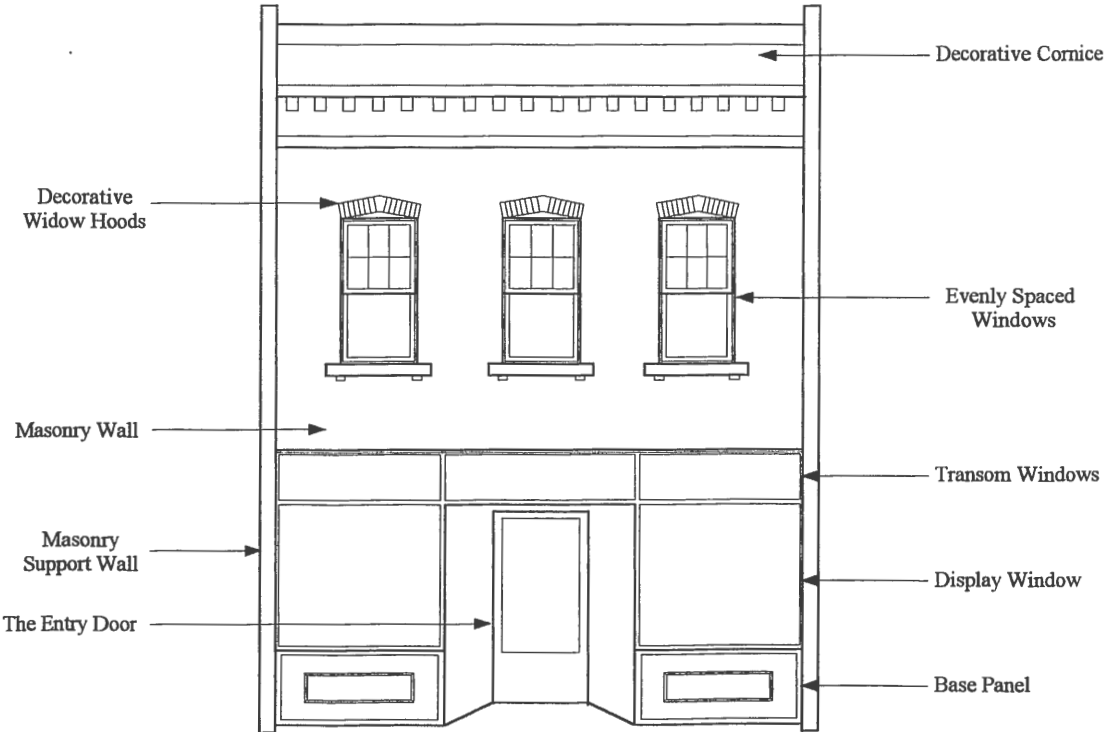
The storefront has gone through some major changes over the years, because of the changes in the way that people shop and different approaches to merchandising. The original shape may be buried under many later renovations, or it may even have been destroyed. It may be possible to find an original photograph in the local library to help in restoration, but it is not necessary to recreate the original facade if it is gone. The 19th Century storefront was essentially "pedestrian friendly" and window shopping was fundamental to the organization of the structure.

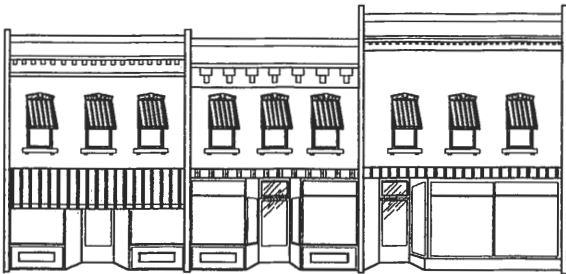
Recommended:

- ◇ Signs and other methods of advertisement should be located so that there is no confusion as to which entrance leads to which store.
- ◇ Maintain original proportions with surrounding buildings.
- ◇ Similar window and storefront openings to adjacent buildings
- ◇ Similarities of scale, color, and design where appropriate and consistent with historic look of adjacent and subject buildings.
- ◇ Create the feeling for patrons and visitors as though they are stepping into individual outdoor rooms created by awnings and recessed doorways that are distinctly separated from one building to another.
- ◇ Design the ground floors in order to catch the eye of the pedestrian and lead him/her into the store to make some purchases or use services.

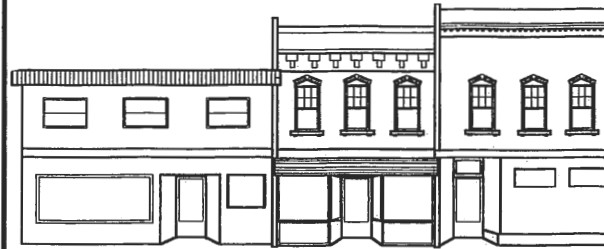
Low Roof Line,
Unproportional window sizes

Not Recommended:

- ◇ Extending the storefront beyond its original borders, so it seems to take over the whole building, thus making the street lose its continuity.
- ◇ Not proportional with adjacent buildings
- ◇ Facades set back from the street

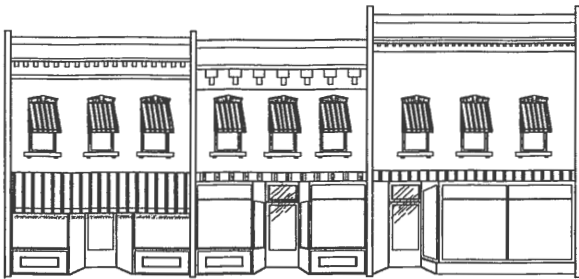
- ◇ Decoration on outside walls should be simple in order to direct potential customers to the display inside.
- ◇ Emphasize the windows and the goods and/or services inside, and use decoration to enhance the window's effect.

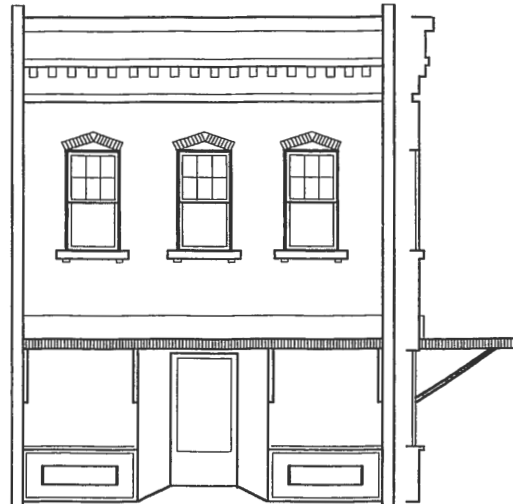
Not Recommended:

- ◇ Aluminum awnings or canopies - they look out of place on a commercial street
- ◇ Non weather-resistant awnings
- ◇ Internally-lit awning-and-sign combinations
- ◇ Barrel-vault shaped awnings — shape of awnings typically should be sloped, with or without side closures and awning flap.

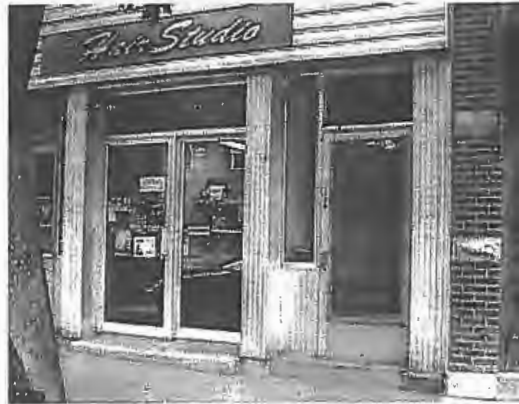
- ◇ Use of materials that clash with the storefront
- ◇ Decoration that extends beyond the original boundaries of the storefront.
- ◇ Bricks that do not match original
- ◇ Siding of any type

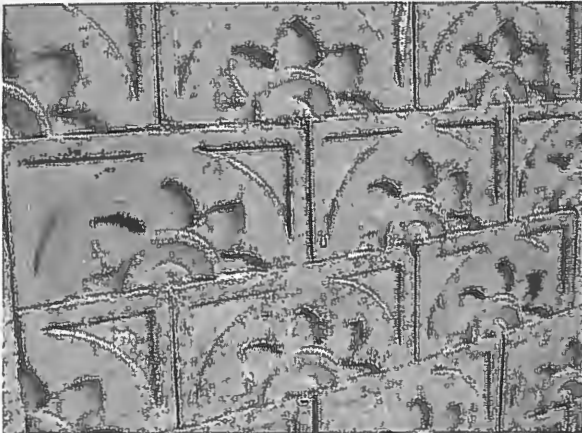
- ◇ Preserve historic details
- ◇ Duplicating original details if it can not be repaired

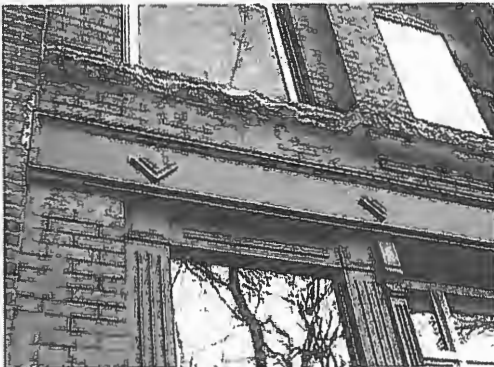
- ◇ Test paint on an area of the building before painting the entire building.
- ◇ To return the building to its original color, carefully scrape a circle of the painted surface to reveal the layers underneath and match to the newer paint.
- ◇ Color schemes of different eras:
 - mid 1800's - 1800's soft neutral tints
 - later 1800's - darker, calmer colors
 - early 1900's - lighter, calmer colors
 - white was rarely used before the early 1900's in town
- ◇ The trim should contrast the shade of the wall to tie the entire building together.

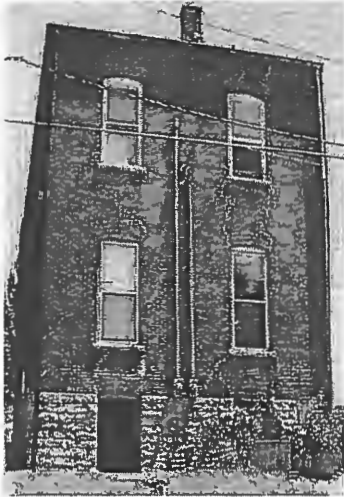
Full-size windows

- ◇ Appears as an entrance
- ◇ Open or rear windows for display
- ◇ Back door more simple than front
- ◇ Smaller windows than the front

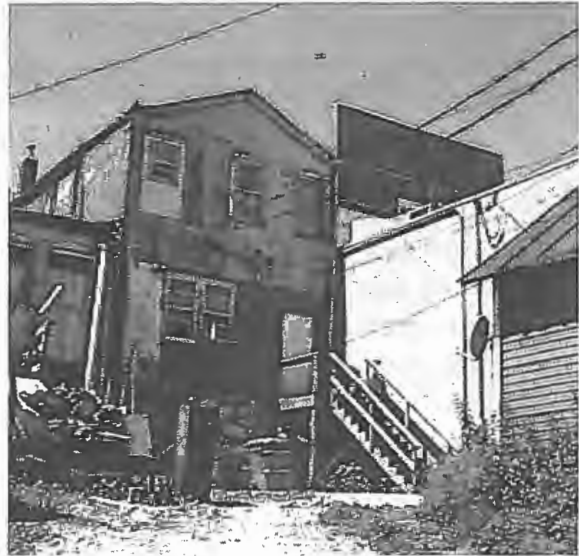
- ◇ An unattractive space
 - overgrowth of weeds
 - not shoveled walks
 - overflowing trash cans

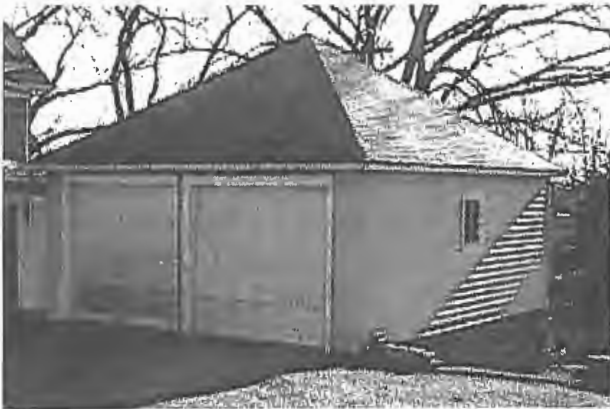
- ◇ Paint siding.
- ◇ Retain original material.
- ◇ Investigate condition before making decisions - stabilization may not be very costly.
- ◇ Make careful assessment of potential space - future owners may use it.
- ◇ Options: tool or garden shed, playhouse, or shop.

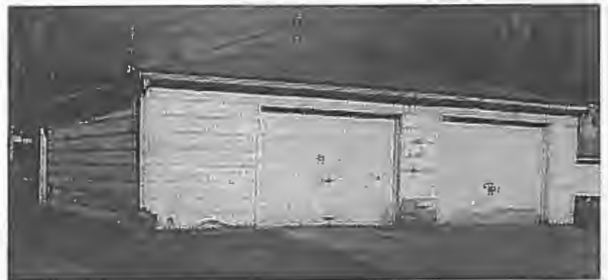
Not Recommended:

- ◇ Adding new openings.
- ◇ Demolition because of age or needs paint.
- ◇ Neglect because hidden in back of lot.
- ◇ Addition of modern materials (aluminum siding, stucco, etc.)

Inappropriate siding and roof pitch
